Electrical Distribution & Power Gear Refurbishment

PROJECT PROFILE

Type of job: Electrical Distribution & Power Gear Refurbishment

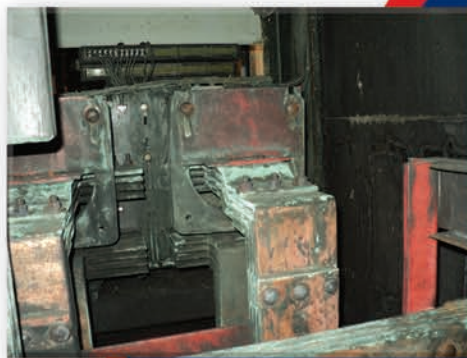
▲ BEFORE

A cotton thread manufacturer had a power outage due to an electrical incident. A main set of conductors from the utility transformer feeding the main gear failed. The insulation smoldered and burnt in the conduit resulting in shorting all feeders in the adjacent conduits. The main distribution panel was heavily damaged by the smoke. The fire was contained and damages were limited to the electrical room & cabinet. The smoldering jacket produced heavy chloride contamination resulting in corrosion throughout the cabinet into the main buss system, lugs, CT's, main breakers and sub breakers. This event brought work at this 24 hour plant to a stand still.

- Removal of main circuit breaker, sub breakers and low voltage components
- Disassembly of cabinet, wire lugs, grounding straps, insulators and busses. Assessment, rebuilding and final testing of main breaker by OEM
- CO² blasting of cabinet and buss components
- Polishing of the buss and repainting of the cabinet
- Reassembly of the buss system including re-torquing of buss bolts
- Third party NETA electrical testing
- Installation of new low voltage controls, amp meter and CT's
