Case Study

Complex Dehumidification for a College Fine Arts Center

Weston, MA

Diagnostics and Dehumidification

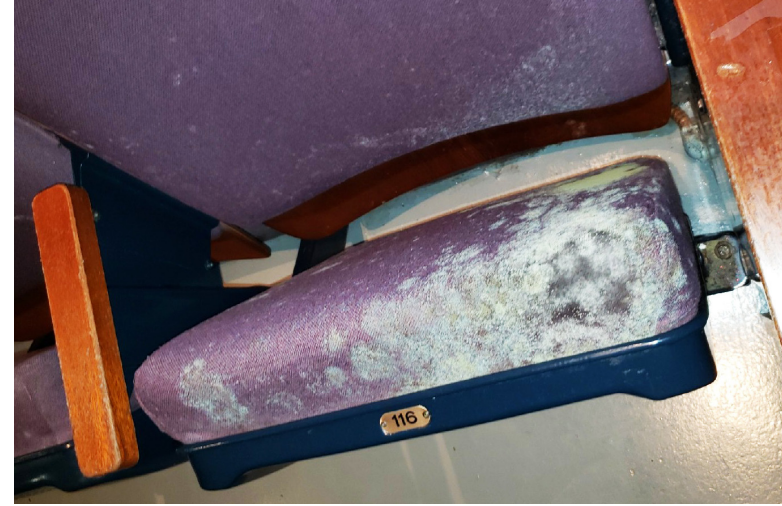
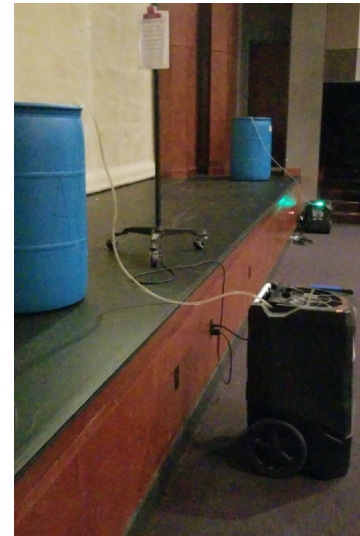
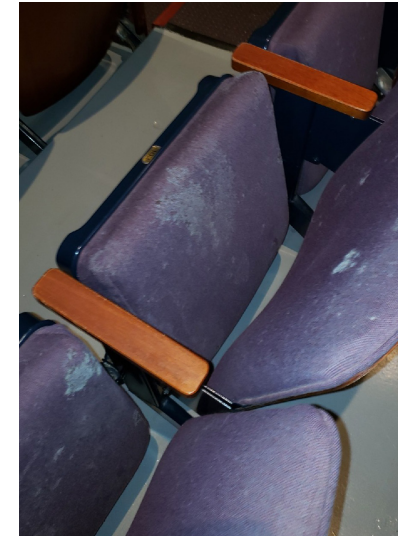
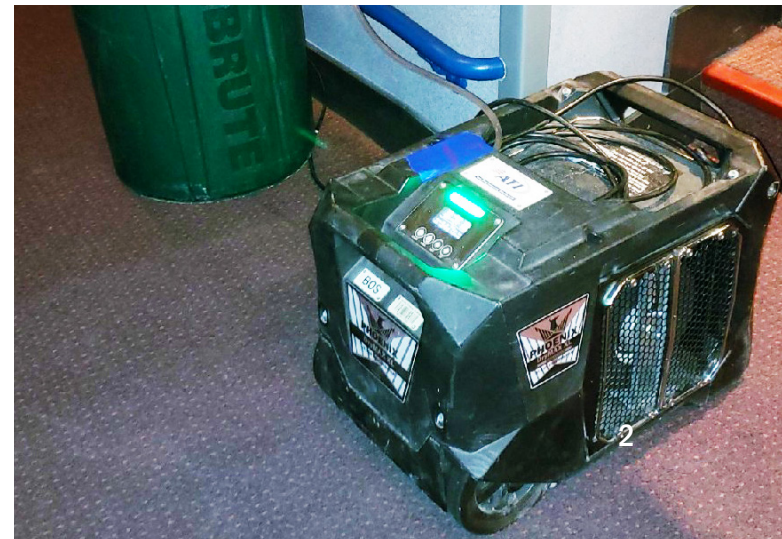
Unusually hot and humid temperatures coupled with a 25-year-old HVAC system created the perfect storm to cause extensive damage in a 650 seat college auditorium. The elevated relative humidity (RH) levels in the theater were reading 70-75%, far greater than the ideal 40-50% for health and comfort. The dewpoint, the temperature at which the air becomes saturated, was in the mid 60s, well above the recommended 55 degrees or lower. The air temperature in the room ranged from the upper 60s to the low 70s.

The high dewpoint combined with the high RH caused water to accumulate on surfaces, which led to a serious mold outbreak on upholstered chairs, carpet and sensitive audio and video equipment in the hall.

ATI's course of action included a highly complex diagnostic and dehumidification plan. Special drying equipment was used to remove moisture, and air-filtration devices were installed to promote air circulation and prevent additional microbial growth. ATI used state-of-the-art thermography equipment and moisture meters to monitor and maintain progress.

Within five days, the dewpoint was decreased, contents were dried and the auditorium was stabilized. After two months, ATI removed its equipment, salvaging the acoustical treatment and sound reinforcement systems in the theater, avoiding expensive replacement costs.
