Case Study

Enhanced Disinfection Technology at a Medical Center

Fullerton, CA

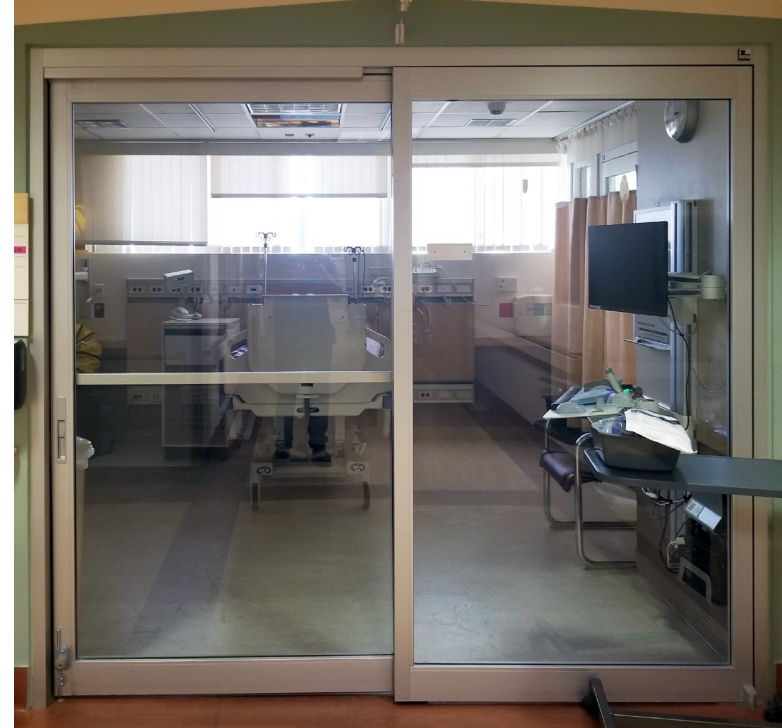
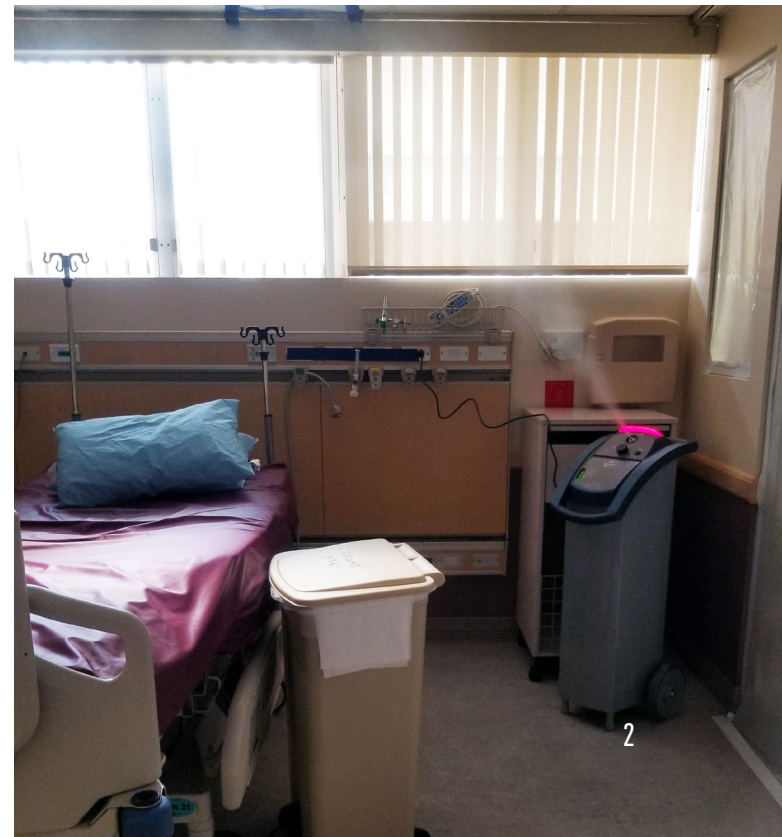
- iii. ATI installed critical barriers to isolate and seal each patient room. The supply diffusers and return grilles were sealed with 6-mil poly and vinyl tape to prevent the aerosolized hydrogen peroxide from migrating throughout the ductwork. The smoke detectors were covered.

- iv. ATI placed 4 Chemical Indicator strips (CIs) throughout the patient room to assure consistent delivery of the disinfectant mist dispensed by the Halofogger.

- v. ATI positioned the Halofogger in the corner of the room approximately one foot away from the wall, ensuring the dispensing airflow pathway was unobstructed during the treatment process. ATI turned on the Halofogger and exited the patient room.
