# Case Study: Tulare Lake Flooding

## Major Event Overview

In March 2023, an extraordinary flooding event occurred in the Tulare region of California, following record snowfall in the Sierra Nevada Mountains during the winter of 2022-2023. As a result, a veterinary research facility at a leading educational institution experienced severe flooding. The lab had to be evacuated, and adjacent facilities were also affected.

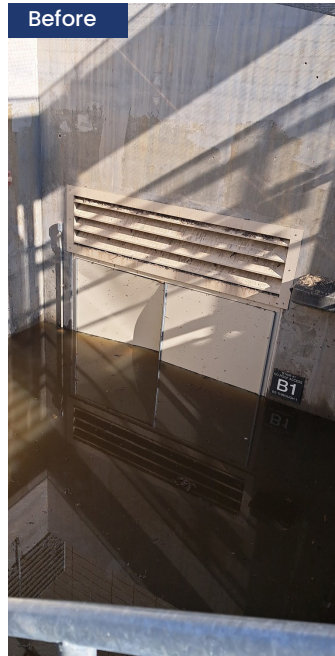
Before

The flooding event affected multiple lab facilities, spanning approximately 25,000 square feet. The flooded area covered around 6,000 square feet, including critical areas such as the incinerator space, with water levels reaching up to 30 feet deep.

Given the amount of flood water, the entire building was underwater, so the ATI team could not observe the affected area. The first step to determine the extent of the damage and prevent additional issues was to extract the water from the basement.

The facility's sump pumps were not working because they were filled with sediment, so ATI secured four trash pumps, all operating simultaneously, to extract the debris. Any remaining liquid was removed by sump pumps. Once the water was pumped out, the remaining challenge was removing the four feet of sediment and mud in the basement and cleaning the facility.
