Electrical Distribution & Power Gear Refurbishment

PROJECT PROFILE

Type of job: Electrical Distribution & Power Gear Refurbishment

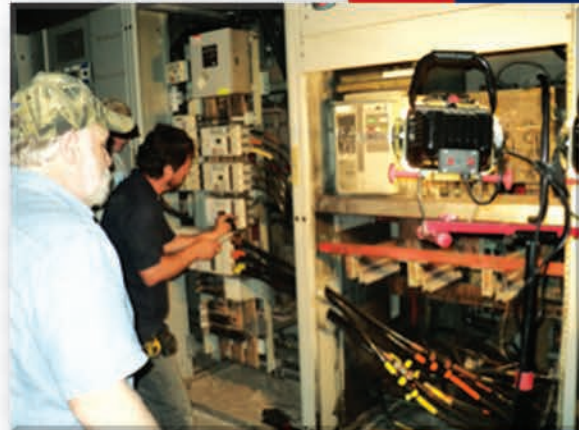
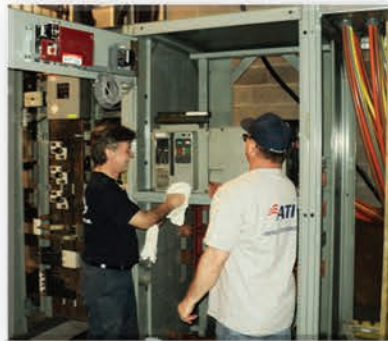
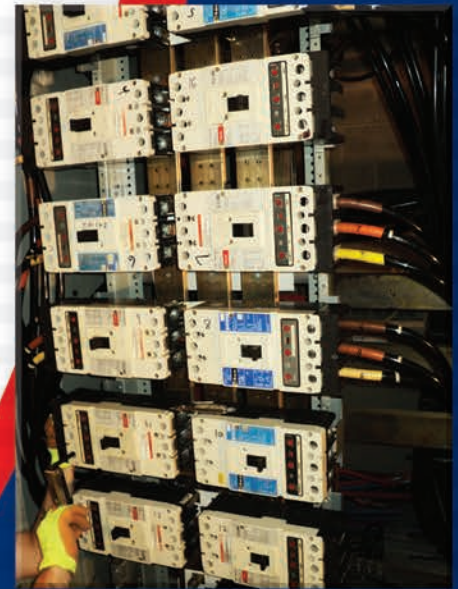
▲ BEFORE

A cotton thread manufacturer had a power outage due to an electrical incident. A main set of conductors from the utility transformer feeding the main gear failed. The insulation smoldered and burnt in the conduit resulting in shorting all feeders in the adjacent conduits. The main distribution panel was heavily damaged by the smoke. The fire was contained and damages were limited to the electrical room & cabinet. The smoldering jacket produced heavy chloride contamination resulting in corrosion throughout the cabinet into the main buss system, lugs, CT's, main breakers and sub breakers. This event brought work at this 24 hour plant to a stand still.

- Removal of main circuit breaker, sub breakers and low voltage components
- Disassembly of cabinet, wire lugs, grounding straps, insulators and busses. Assessment, rebuilding and final testing of main breaker by OEM
- CO² blasting of cabinet and buss components
- Polishing of the buss and repainting of the cabinet
- Reassembly of the buss system including re-torquing of buss bolts
- Third party NETA electrical testing
- Installation of new low voltage controls, amp meter and CT's
